# 2074 Console Support Controller Installation and Maintenance Information

G229-9028-03

This document refers to the IBM® 2074 Console Support Controller.

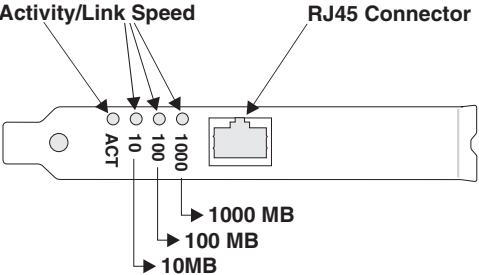
<p>Activity/Link Speed      RJ45 Connector</p> <p>ACT    10    100    1000</p> <p>→ 1000 MB → 100 MB → 10MB</p>
<p><b>Start Planar Ethernet Diagnostic</b></p>	
<p><b>3</b> Is a cable plugged into the Ethernet port on the planar?</p> <p><b>Yes      No</b></p> <p><b>Next</b>    No LANs are in use</p> <p>Is the link ok LED in the RJ-45 socket on solid?</p> <p><b>Yes      No</b></p> <p><b>Next</b>    Refer to Table 2.5</p>

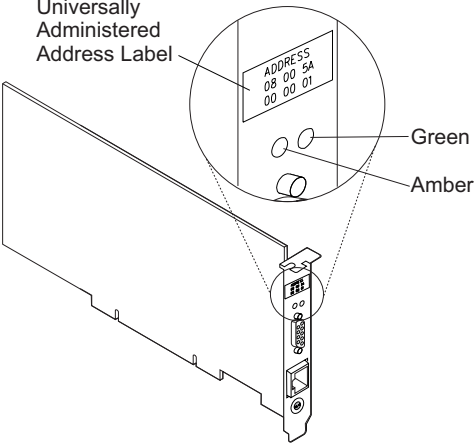
Table 2-6. Startup Sequence of LED States

Amber	Green	Explanation
Blinking	Blinking	The adapter is waiting for initialization
Off	Off	The adapter initialization is in progress, or the computer is powered off.
Off	Blinking	The adapter did not detect any problems during its self-diagnostic tests and is waiting to open. If this LED state occurs after the adapter has been opened, this state indicates that the adapter has been closed under software control.
Off	On	The adapter is open and operating correctly.

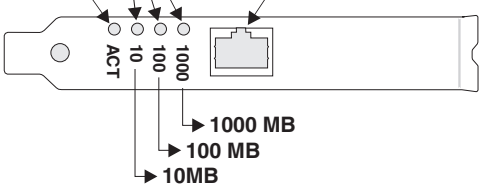
<p><b>9</b></p> <p>Examine the LEDs located on the cable end bracket. There are four LEDs on the Ethernet PCI adapter:</p> <p><b>ACT (for activity) LED:</b></p> <ul style="list-style-type: none"> <li>• Off <ul style="list-style-type: none"> <li>– The adapter is not sending or receiving network data <i>or</i></li> <li>– The adapter and switch are not receiving power <i>or</i></li> <li>– The cable connection between the switch and the adapter is faulty <i>or</i></li> <li>– You have a driver configuration problem</li> </ul> </li> <li>• Flashing <ul style="list-style-type: none"> <li>– The adapter is sending or receiving network data. The frequency of the flashes varies with the amount of network data.</li> </ul> </li> </ul> <p><b>Link Speed LEDs:</b></p> <ul style="list-style-type: none"> <li>• On - indicates link speed.</li> <li>• Off - Refer to Table 2-8.</li> </ul>	<p><b>Activity/Link Speed</b></p> <p><b>RJ45 Connector</b></p>

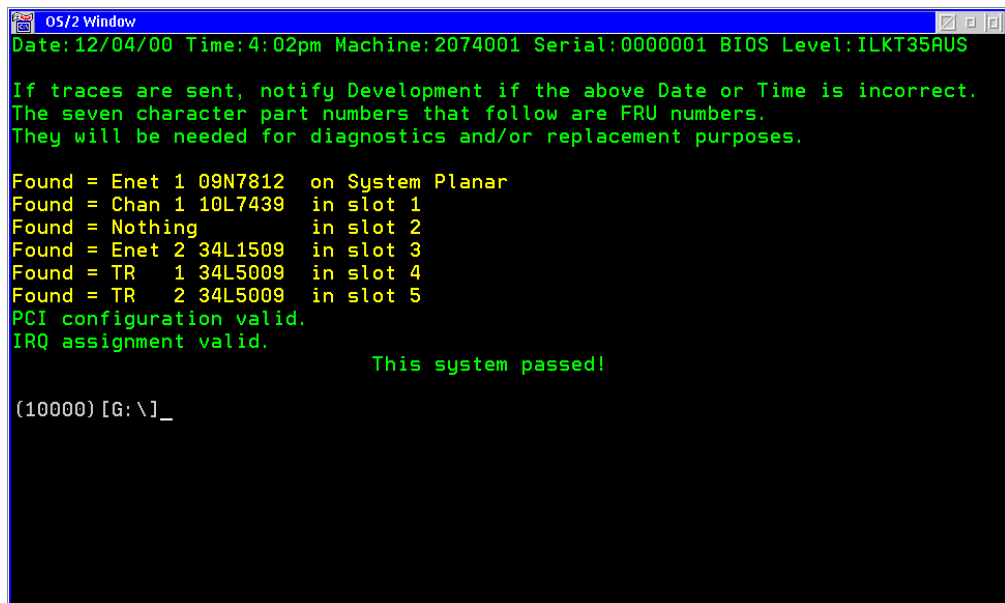
From an OS/2 Window execute the command CHECKPCI. Did it pass? There should be nothing in red. If no, verify why the PCI adapters aren't where they belong. This will verify that unknown adapters aren't installed and that none are missing. If adapters are missing, the LAN card numbering will be incorrect. This is not acceptable.

```
OS/2 Window
Date:12/04/00 Time:4:02pm Machine:2074001 Serial:0000001 BIOS Level:ILKT35AUS

If traces are sent, notify Development if the above Date or Time is incorrect.
The seven character part numbers that follow are FRU numbers.
They will be needed for diagnostics and/or replacement purposes.
